Data and Methods of a 1999–2000 Street Sweeping Study on an Urban Freeway in Milwaukee County, Wisconsin

Open-File Report 03–93

By Robert J. Waschbusch

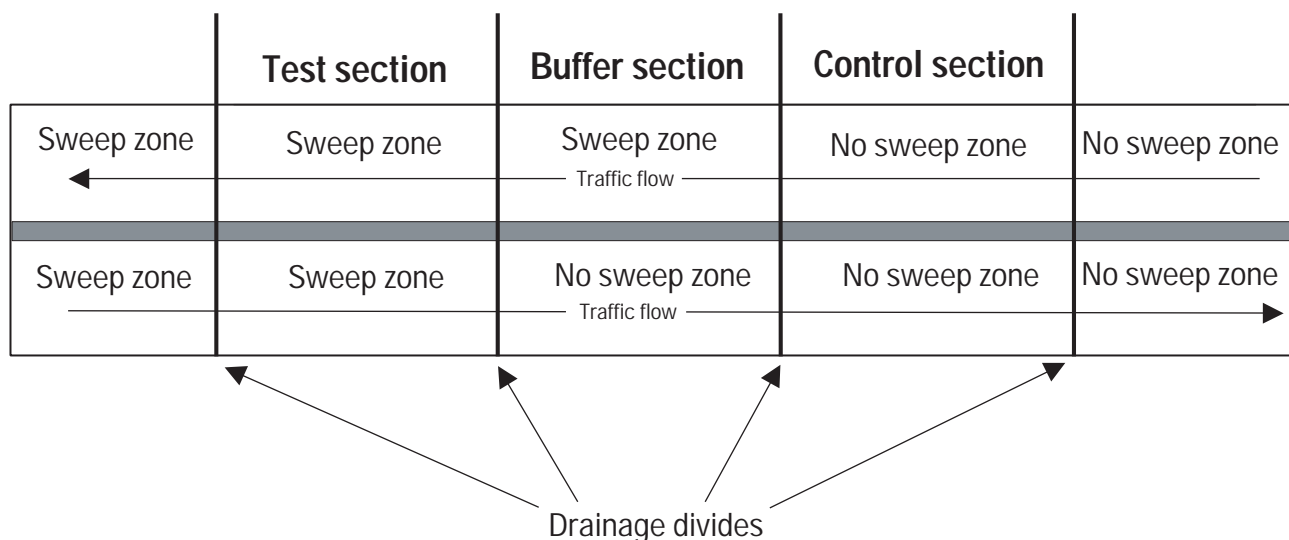
Figure 1. Diagram of study area.

The study area was a section of Interstate 894, west of Milwaukee, one of the busiest stretches of roadway in Wisconsin, where a test basin had the street-sweeping program implemented and a control basin did not. The two basins were located between National Avenue and Oklahoma Avenue with a 1,100-ft. long buffer section between them. The purpose of the buffer section was to allow vehicles entering each study basin to travel over pavement that had been either swept or not swept so that the dirt the vehicle “pulled” into the basin would be comparable to either swept or unswept conditions (fig. 1).

The test basin, which was between Oklahoma Avenue and Dakota Street, had a drainage area of 4.56 acres that was comprised of 4.31 acres of highway surface and 0.25 acres of grassy area (fig. 2). Of the highway surface 1.56, 2.67, and 0.08 were the shoulder, the driving lanes and the median, respectively.

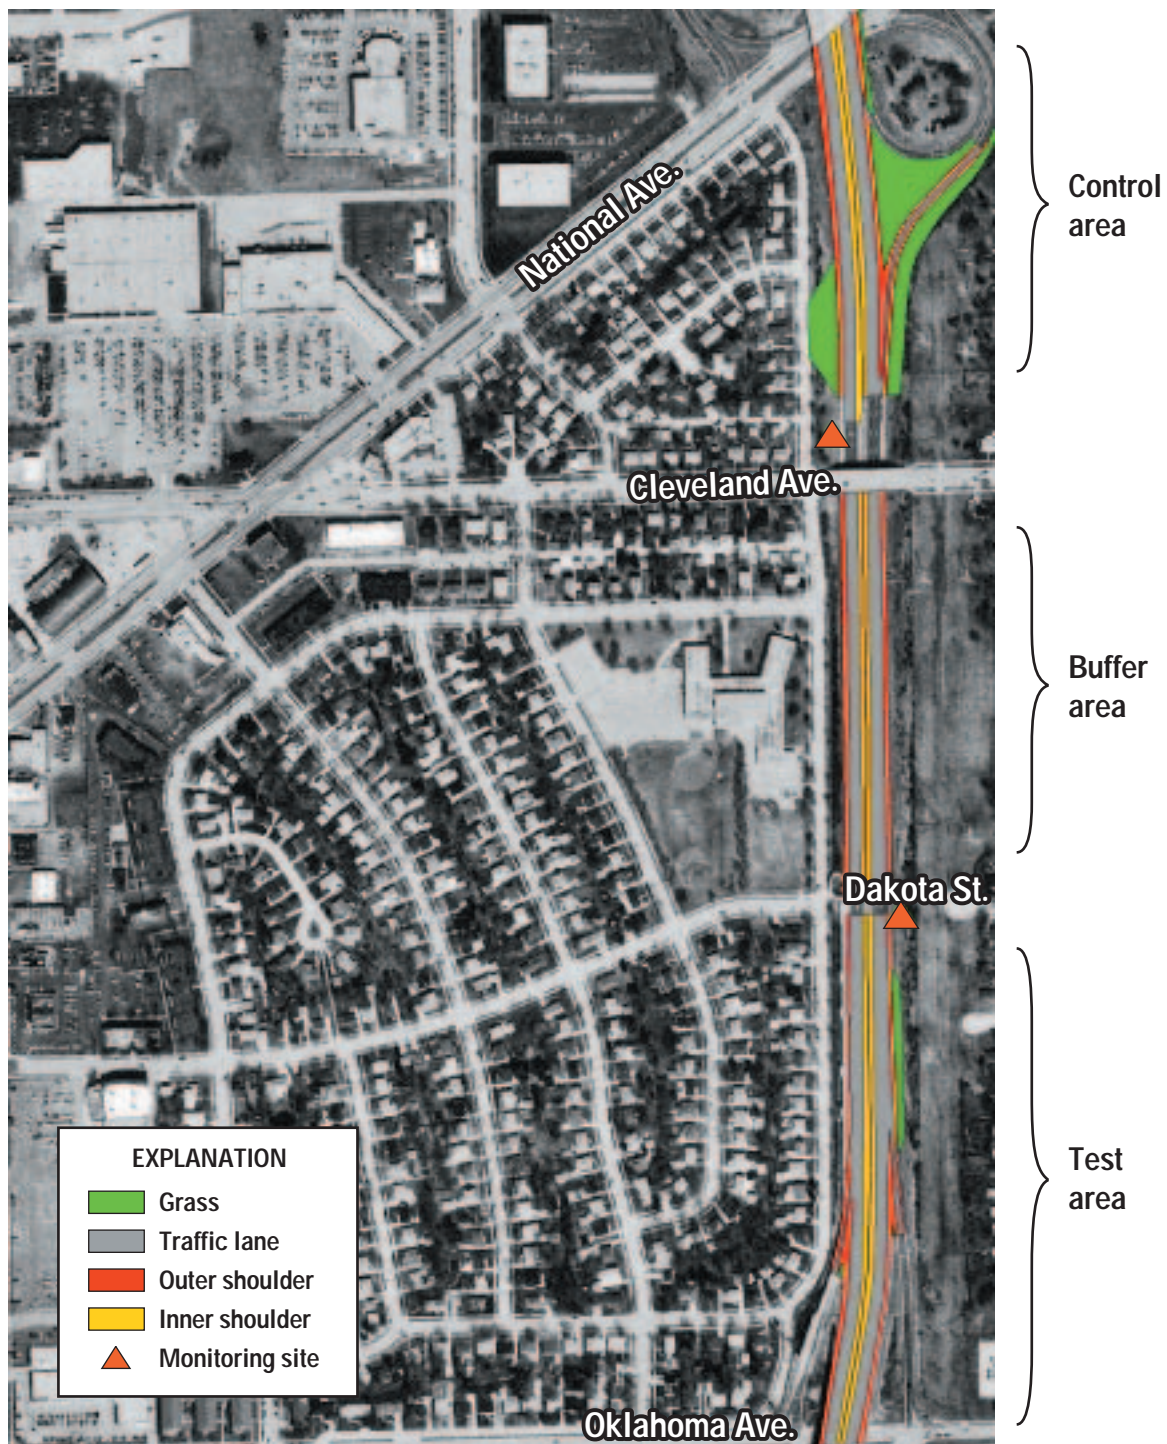
Figure 2. Study area with a GIS overlay detailing the test, control, and buffer areas.

Continuous-recording-traffic counters recorded 15-minute vehicle counts in both traffic directions at Cleveland Ave. (fig. 2). These data were summarized for runoff and sampling periods in appendix table A13.

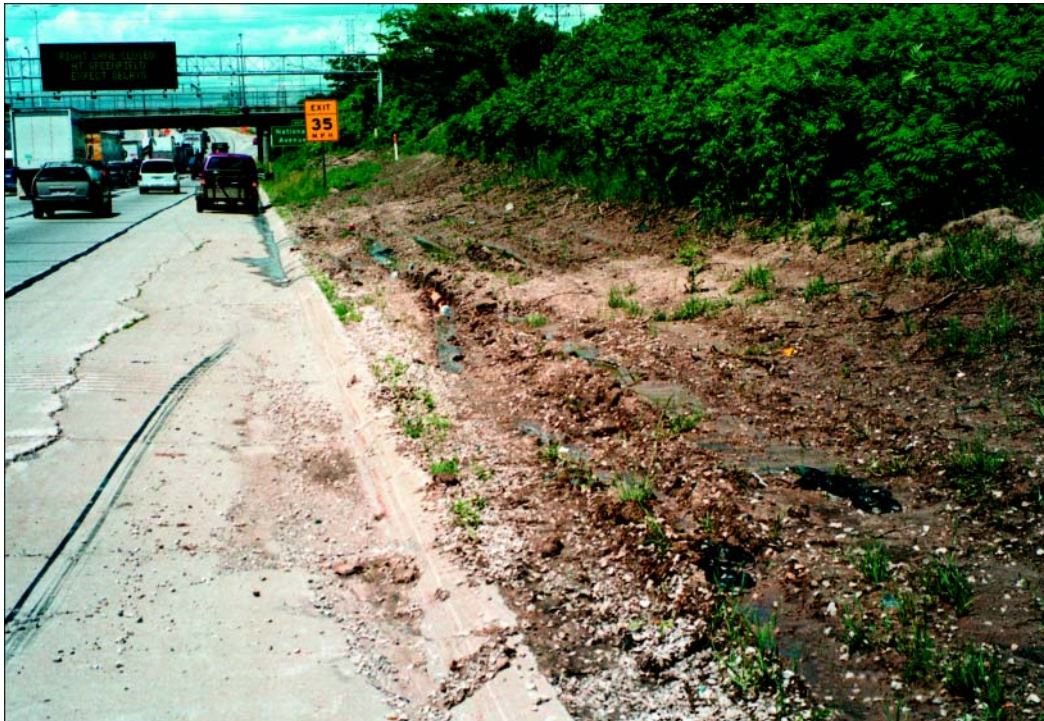
Figure 3. Example of dirt and gravel from utility construction on highway shoulder.

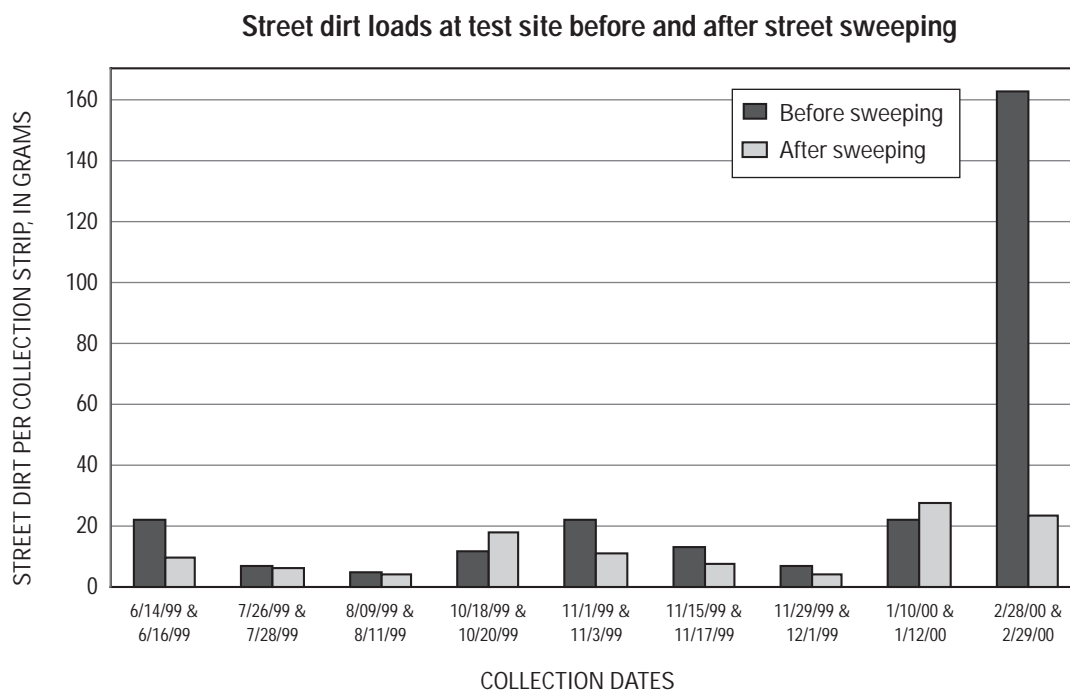
Figure 4. Street dirt loads at test site before and after street sweeping.

Data from the street dirt vacuuming and sieving are presented in appendix tables A1 and A2. Table A3 shows particle-size data from dirt collected by the Enviro Whirl. Changes in dirt mass on the street surfaces before and after sweeping are plotted in figures 4 and 5. At the test site the mass of dirt on the street decreased by 25 percent on average (n=9). At the control site the mass of dirt on the street on the

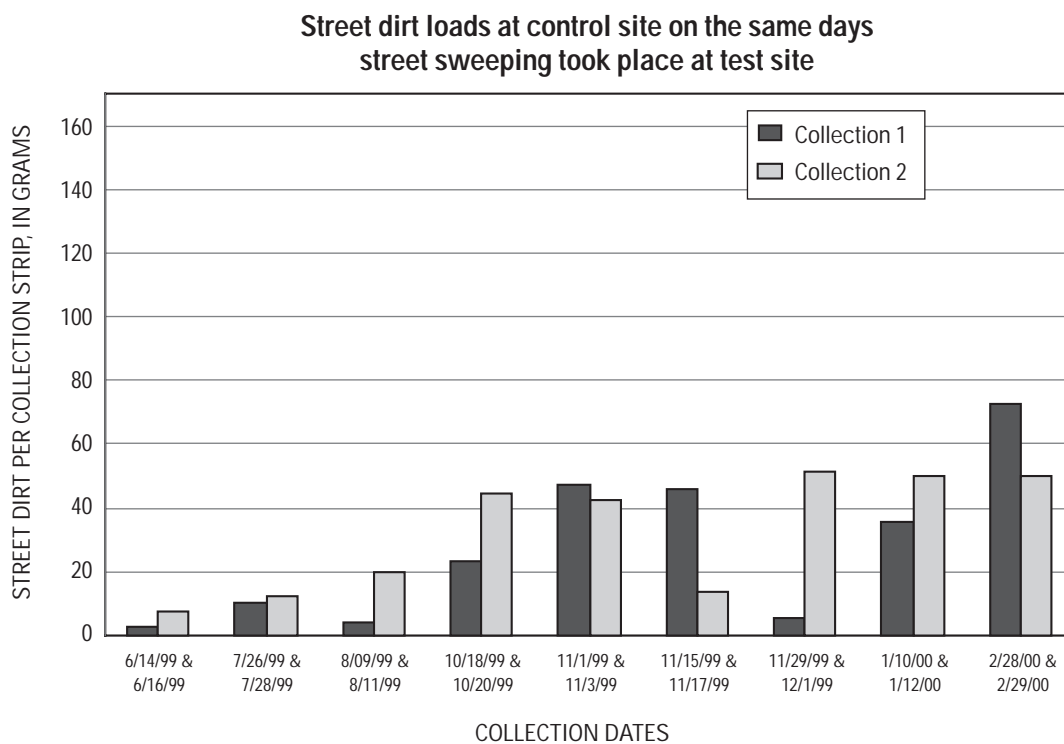
Figure 5. Street dirt loads at control site on the same days street sweeping took place at test site.

same collection dates as the test site (but no street sweeping) increased 160 percent on average ($n=9$).

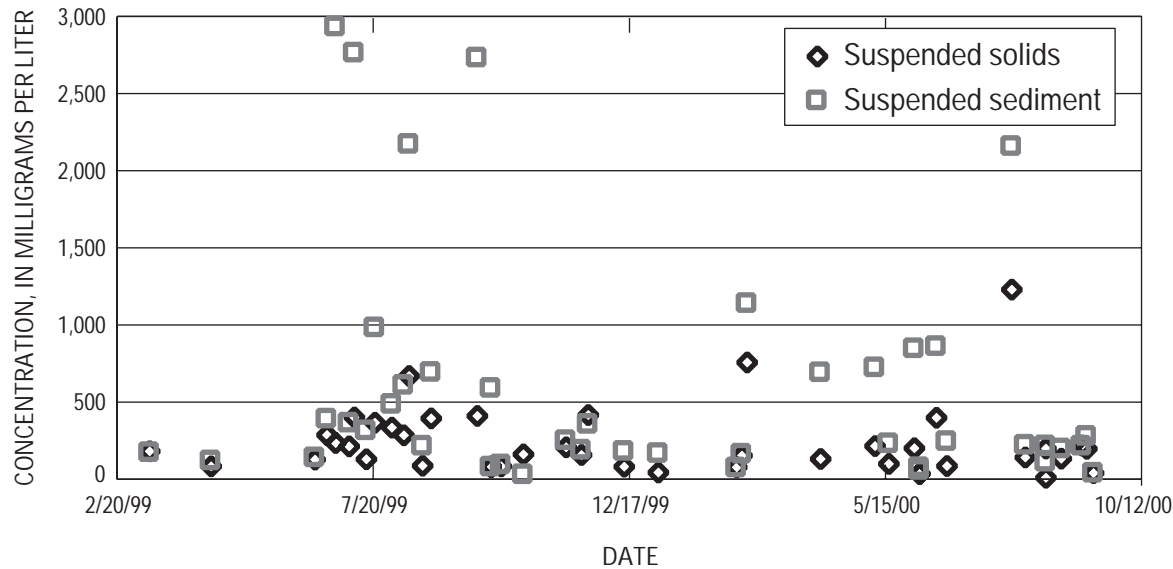
Figure 6. Suspended solids versus suspended sediment at the test site.

After viewing the data (fig. 6) and consulting the report by Gray and others (2000) it was determined that analysis of this study data should use suspended sediment (S. Sed.) rather than suspended solids (TSS). These two parameters are similar in that they measure the mass of particles in water, however the laboratory analysis methods are different. It appears that the suspended solids analysis does not work well for samples with large particles, which results in concentrations that are biased low. The difference in the analysis methods may be particularly important when viewing roadway-runoff data because of the prevalence of larger-sized particles, which appear to accentuate the differences in results between the two constituents.
